# Flight Helmet Cords Can Impede Egress

## ■ Understand the hazard of direct-to-airframe cord connections

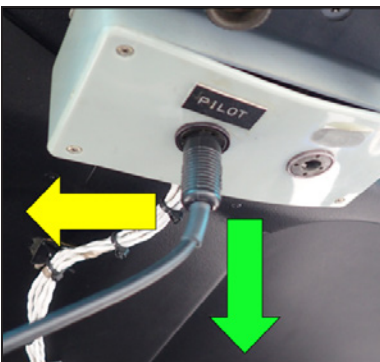
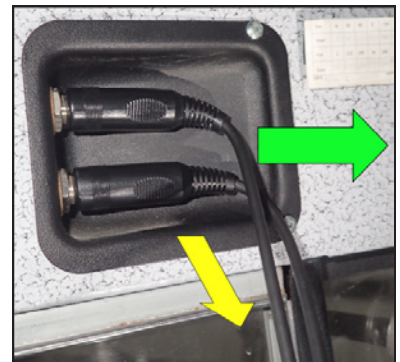
- In the event of an accident or emergency in which an aircraft occupant wearing a flight helmet needs to egress quickly (such as a ditching, water impact, or fire), fast and unimpeded egress from the aircraft is essential for survival. **Direct-to-airframe intercommunication system (ICS) cord connections between the flight helmet and the airframe can impede egress during an accident or emergency.**<sup>1</sup>
- **The cord connecting the flight helmet to the aircraft's ICS might not release readily from the airframe ICS port if the direction of egress is contrary to the direction needed to easily release the cord** (see figures 1a and 1b). For instance, if a cord needs to be pulled downward for release and an aircraft occupant is attempting a sideward egress, the cord may not release readily, which could cause excess delays in egress.

**Figures 1a and 1b.** Airbus (formerly Eurocopter) AS-350 B2 (left) and Piper PA-18-150 (right) pilot-seat airframe ICS ports. The green arrows show the direction needed to easily release the ICS cords, and the yellow arrows show the direction of occupant egress.

- **Ensure that you and your passengers understand and are proficient with the egress procedures for the aircraft that you are operating before you take off.**
- **Use a compatible intermediate cord between the ICS cord and the airframe ICS port to facilitate a clean separation during egress. The intermediate cord is a cord connecting to the airframe ICS port on one end and to the ICS cord on the other end, allowing the ICS cord to be disconnected in the direction of egress.**
- **Ensure that ICS cords are secured from potential snagging or entanglement with components such as flight controls.**

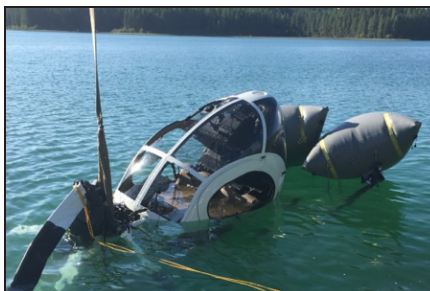
■ **The pilot of an MD Helicopters (formerly Hughes) MD-369E lost control while filling a water bucket at night over a lake** (see figures 2 and 3).

After the helicopter impacted the water, inverted, and started sinking, the pilot pulled himself out of the cockpit. **He reported that, as he came out of the cockpit underwater, he felt his flight helmet tug backwards; the ICS cord was still attached to the airframe port.**

**Figure 2.** Helicopter in water.  
PHOTO BY TWO BEAR AIR 2 LLC (OPERATOR)

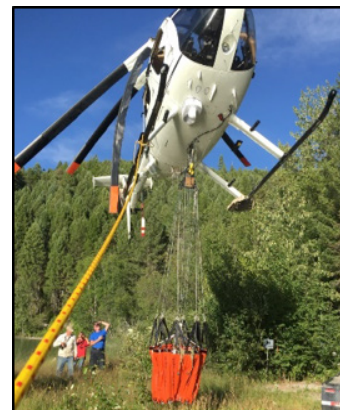
**Figure 3.** Recovered helicopter.  
PHOTO BY FAA

The pilot removed his flight

helmet, surfaced, and swam to the shore without further incident; he sustained minor injuries. ([GAA15LA217](#))

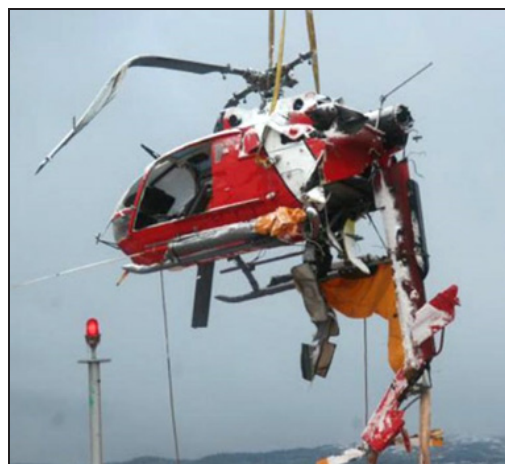
■ **An Airbus Helicopters (formerly Messerschmitt-Bölkow-Blohm) MBB B0105 impacted water while flying at low altitude over a bay in snow and darkening conditions in Canada** (see figure 4). The helicopter

sank, and the pilot and passenger were able to egress from the helicopter. After the egress, the pilot died from hypothermia, and the passenger drowned. **A postaccident examination of the pilot's flight helmet revealed that the end fitting of the ICS cord was fractured where it attached to the port. Metal remnants showed that the cord was being pulled sideways toward the pilot's door (as opposed to downward for release) when the fracture occurred;** a postaccident test of a similar fitting required a 70-lb pull before the cord failed. (TSB Report [A05A0155](#))

**Figure 4.** Recovered helicopter.

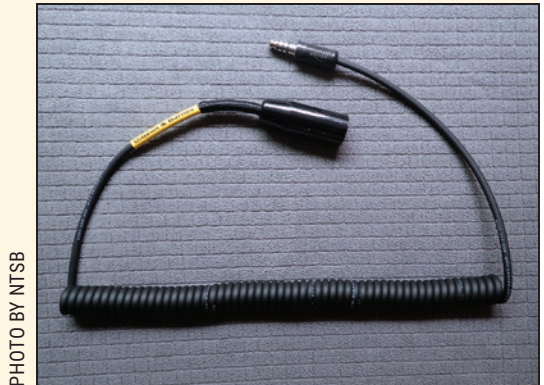
Figure 5. Exemplar intermediate cord.
